**2013 Operations, Maintenance, and  
Monitoring Report**

**Holly Beach Sand Management**

State Project Number CS-31  
Priority Project List 11

June 2013  
Cameron Parish

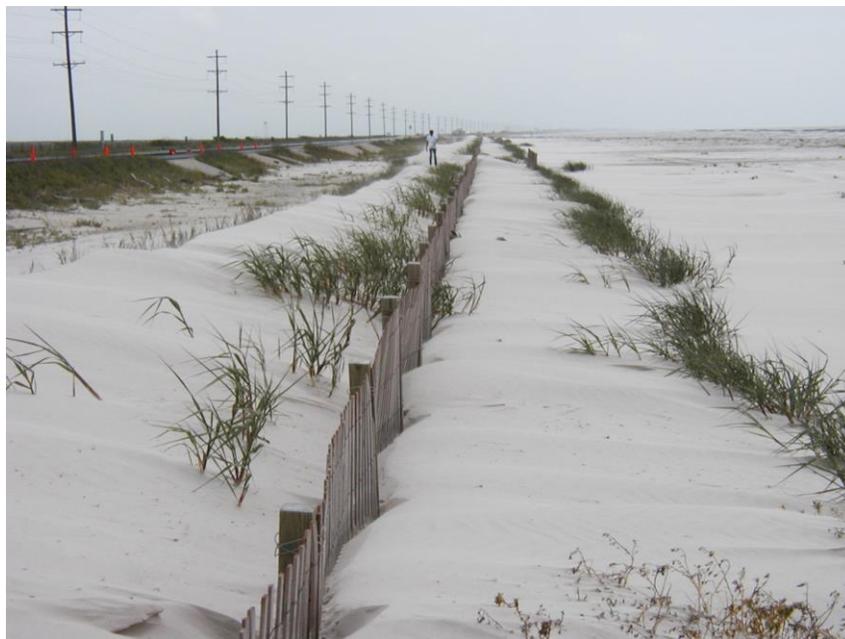
**Figure 9a.** View of the sand fencing and Vegetation Plantings at Station CS31-108 taken in April 2004. Note the dune formation almost covering the fences. The photograph is facing east.

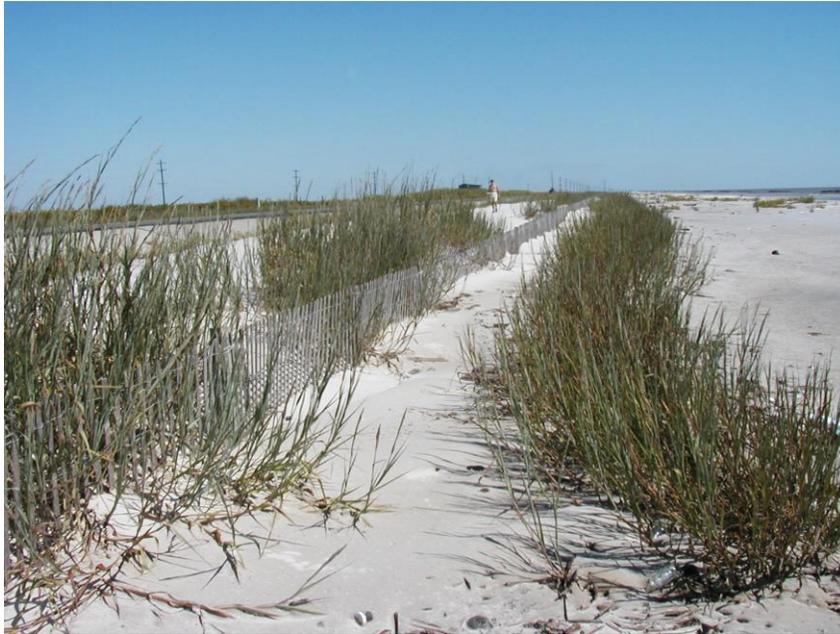
**Figure 9b.** View of the Sand Fencing and Vegetation Plantings at Station CS31-150 taken in October 2004. The photograph is facing east.

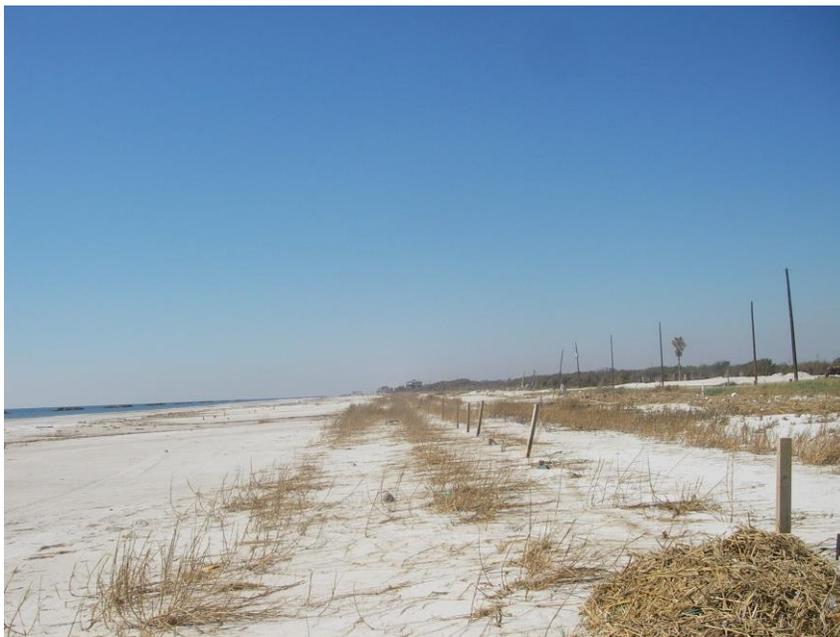
**Figure 9c.** View of a section of the sand fencing and vegetation plantings taken October 2005, following Hurricane Rita. The photograph is facing west.

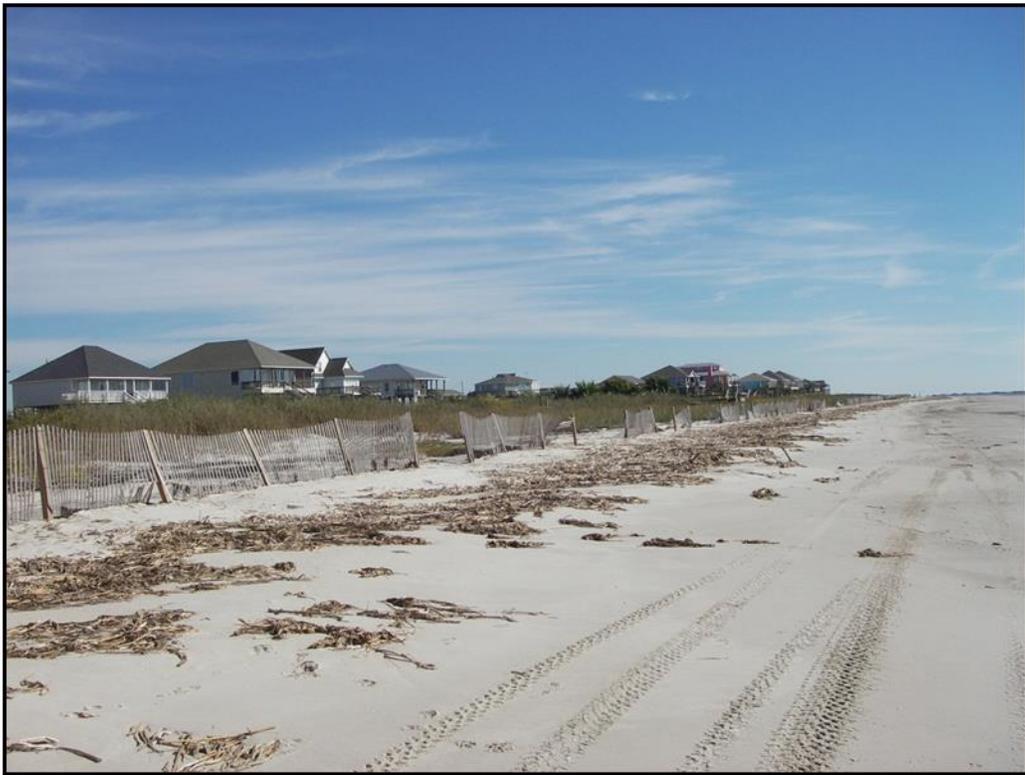
**Photo No. 1**, Typical sand fence section on westernmost end of project

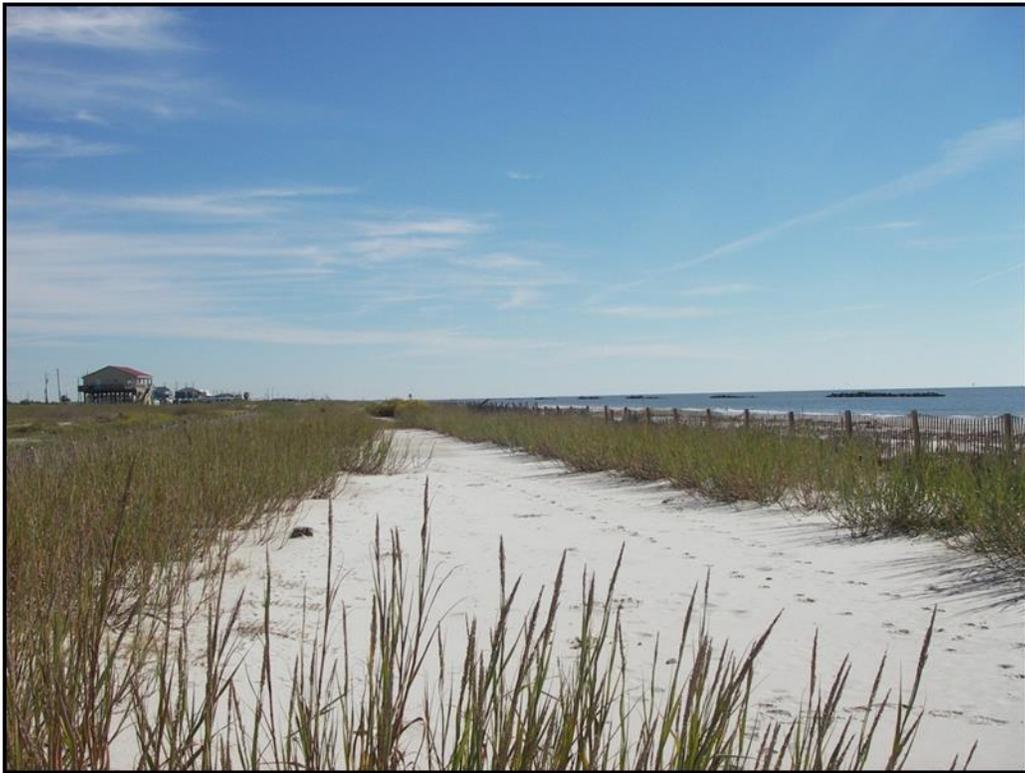
There are areas of fencing still intact on higher ground that are showing good dune formation, as well as healthy plant growth. (Photos: Appendix B, Photos 1 - 5).

**Photo No. 2**, Double fence section with plantings thriving

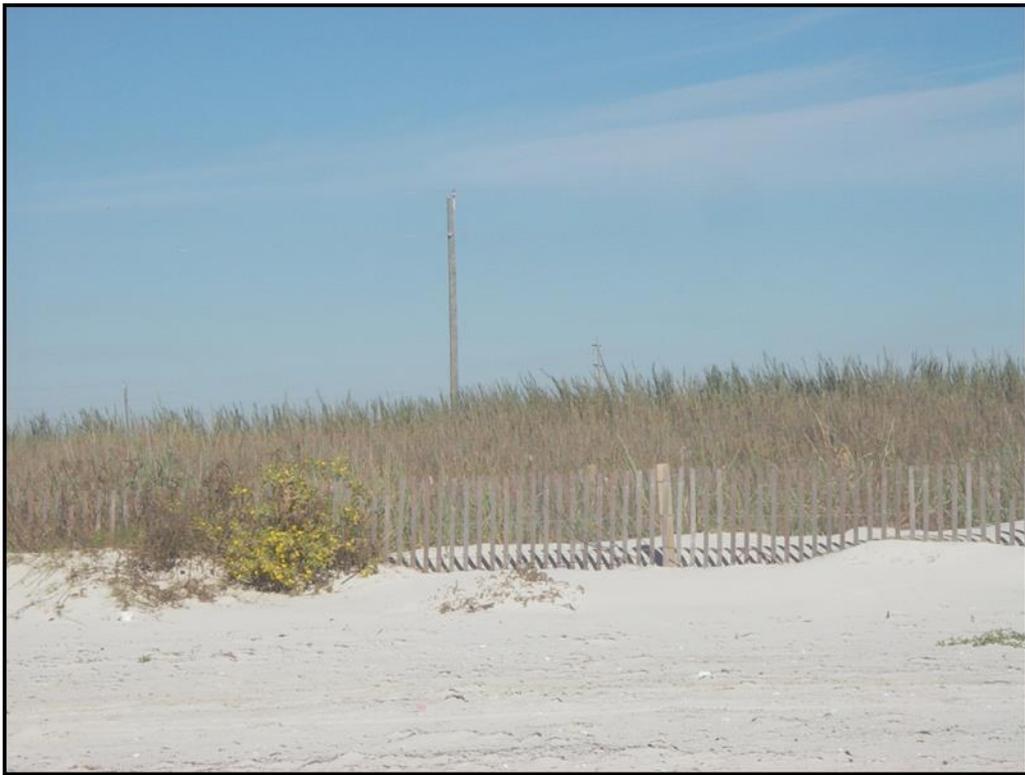
**Photo No. 3**, Good dune formation on fence section not affected by tidal waters

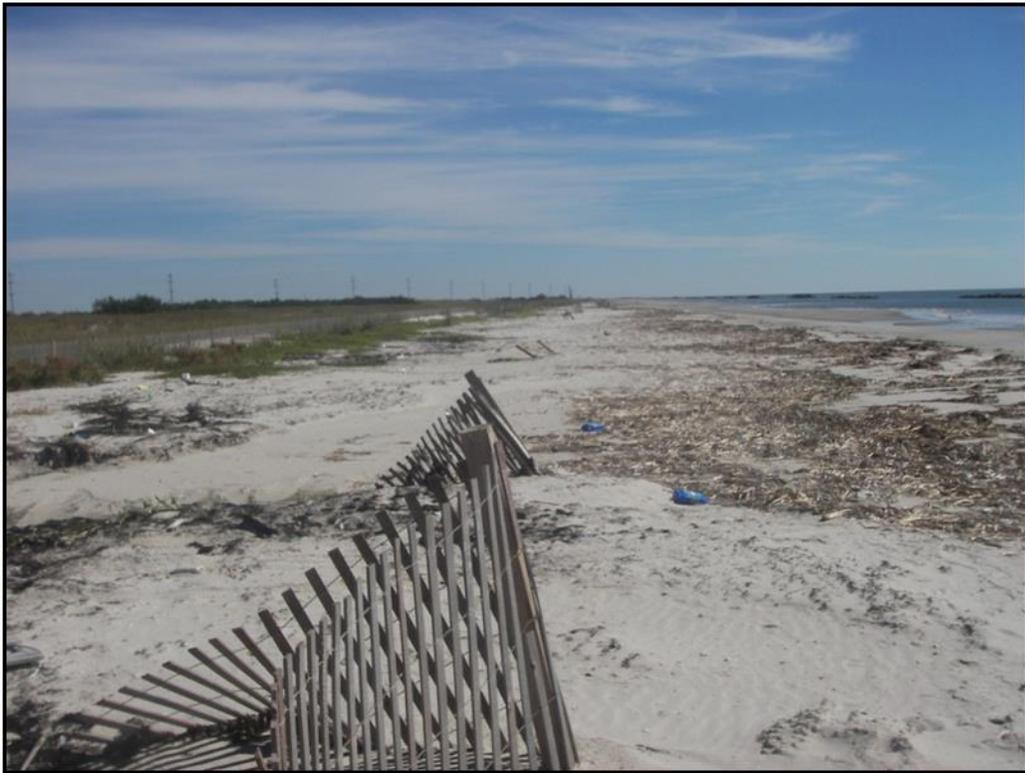
The sand fence has suffered extensive damage due to tidal action. There were many sections of considerable length where the fence fabric was completely removed from the posts. We did not

generally see many broken sections of fence material lying on the beach. There are many bare posts remaining.

**Photo No. 4**, Long section of damaged fence

There are fence posts left standing where the beach has washed significantly and the fence is no longer present. It was decided at this time not to repair the fence in the section of beach where there is now high wave activity. The remaining posts will be removed in a future contract if it is seen that they pose a safety hazard.

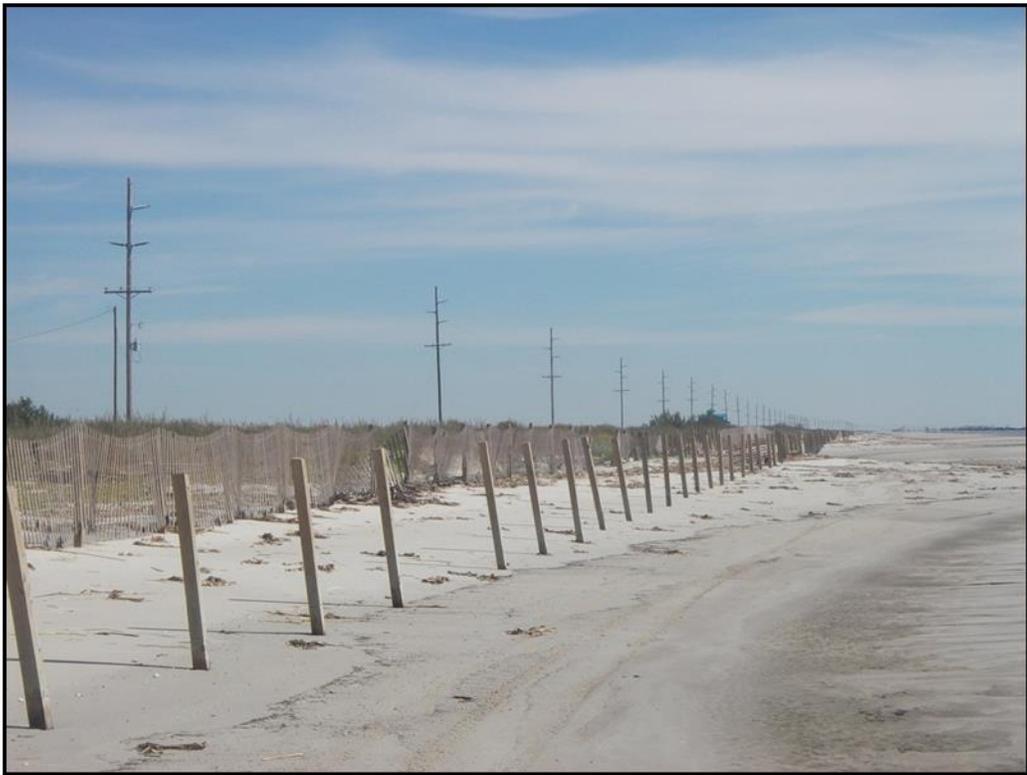
**Photo No. 5, More damaged fence**
